**Flood Control Project Maintenance
Levee Inspections**

2019 Channel Summary Report

Tehama County Flood Control and Water Conservation District

Levee Inspection Report By Mile - Channel 2019

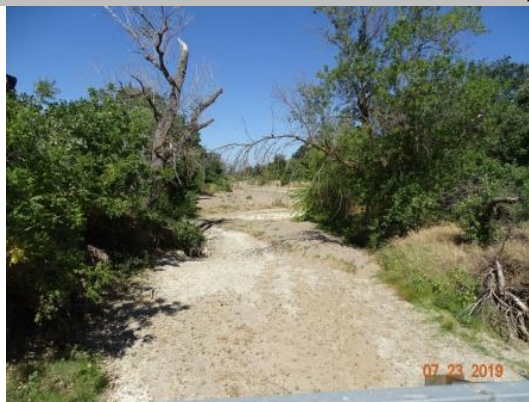
Photo 1 of 1 : CH_2019_NA0019_3_1_20190726_00008.jpg

Rating **	A	Issue No.	1	GPS Lat/Long
Issue Type +	Ma	Location *		40.009840 °
Category	Rivers, Channels & Designated Flood			-122.200180 °
Item	Vegetation & Obstructions			
DWR ID	DWR_NA0019_3_c_2012_1			
Action/Comments

View of the upstream extension of McClure Creek at Truckee Avenue.

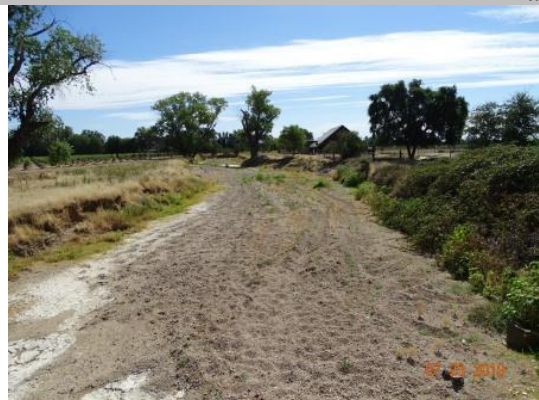
Photo 1 of 1 : CH_2019_NA0019_3_6_20190726_00009.jpg

Rating **	A	Issue No.	6	GPS Lat/Long
Issue Type +	Ma	Location *		40.009840 °
Category	Rivers, Channels & Designated Flood			-122.200180 °
Item	Vegetation & Obstructions			
DWR ID	DWR_NA0019_3_c_2012_6			
Action/Comments				
Inspector Comments: No vegetation in the channel.

View of the downstream extension of McClure Creek at Truckee Avenue.

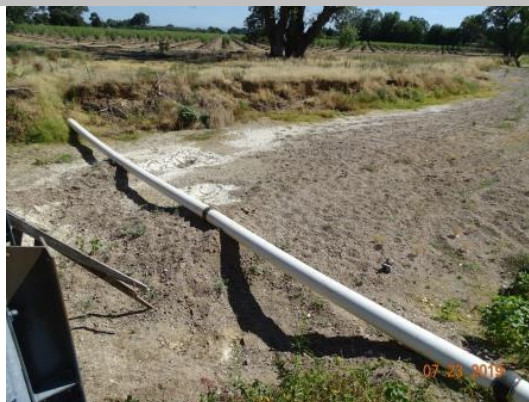
Photo 1 of 1 : CH_2019_NA0019_3_10_20190726_00010.jpg

Rating **	U	Issue No.	10	GPS Lat/Long
Issue Type +	En	Location *		40.009840 °
Category	Rivers, Channels & Designated Flood			-122.200180 °
Item	Encroachments			
DWR ID	DWR_NA0019_3_c_2012_10

View of the pipe encroachment crossing the McClure Creek.

Inspector Comments: The unauthorized pipe crossing should be removed from the channel before winter.

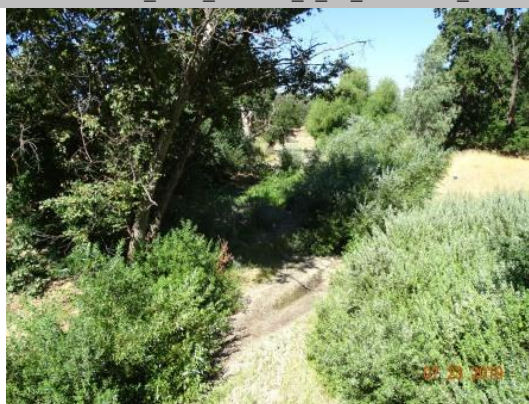
Photo 1 of 1 : CH_2019_NA0019_3_11_20190726_00011.jpg

Rating **	M	Issue No.	11	GPS Lat/Long
Issue Type +	Ma	Location *		40.007430 °
Category	Rivers, Channels & Designated Flood			-122.171780 °
Item	Vegetation & Obstructions			
DWR ID	DWR_NA0019_3_c_2012_11

Upstream view of the McClure Creek from Highway 99W.

Inspector Comments: Remove vegetation obstructing the flow in the channel before winter.

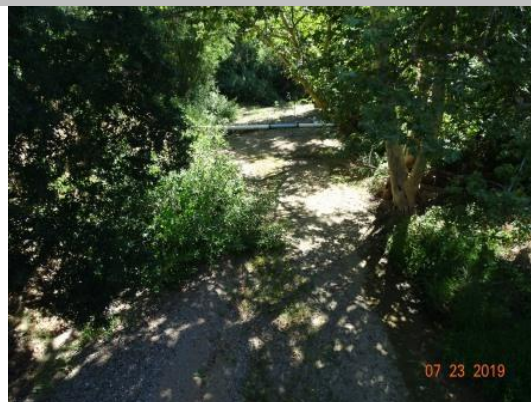
Photo 1 of 1 : CH_2019_NA0019_3_16_20190726_00012.jpg

Rating **	M	Issue No.	16	GPS Lat/Long
Issue Type +	Ma	Location *		40.007430 °
Category	Rivers, Channels & Designated Flood			-122.171780 °
Item	Vegetation & Obstructions			
DWR ID	DWR_NA0019_3_c_2012_16			
Action/Comments				
Inspector Comments: Remove vegetation obstructing the flow in the channel before winter.

Downstream view of the McClure Creek from Highway 99W.

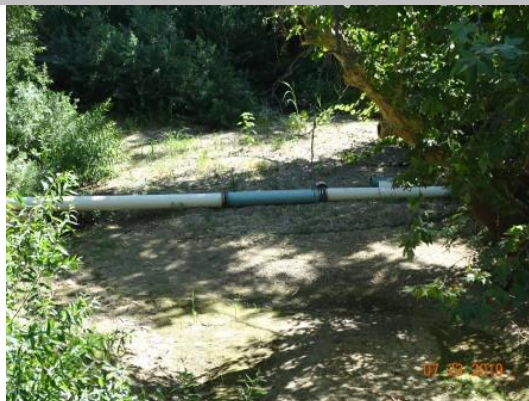
Photo 1 of 1 : CH_2019_NA0019_3_20_20190726_00013.jpg

Rating **	U	Issue No.	20	GPS Lat/Long
Issue Type +	En	Location *		40.007430 °
Category	Rivers, Channels & Designated Flood			-122.171780 °
Item	Encroachments			
DWR ID	DWR_NA0019_3_c _ 2012_20			
Action/Comments				
Inspector Comments: The unauthorized pipe crossing should be removed from the channel before winter.

View of the pipe encroachment crossing the McClure Creek.

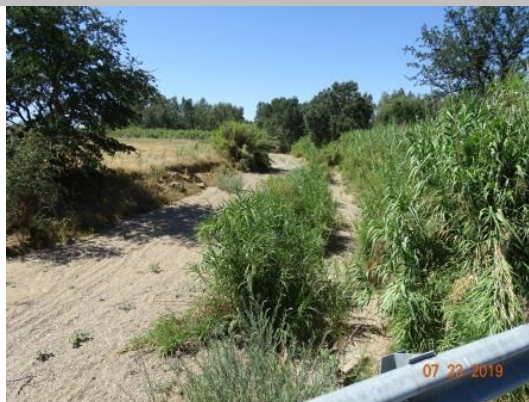
Photo 1 of 1 : CH_2019_NA0019_3_41_20190726_00014.jpg

Rating **	M	Issue No.	41	GPS Lat/Long
Issue Type +	Ma	Location *		40.017400 °
Category	Rivers, Channels & Designated Flood			-122.146540 °
Item	Vegetation & Obstructions			
DWR ID	DWR_NA0019_3_c_2012_41

Upstream view of McClure Creek from Hamilton Road.

Inspector Comments: Remove vegetation obstructing the channel before winter. Arrundo should be eradicated.

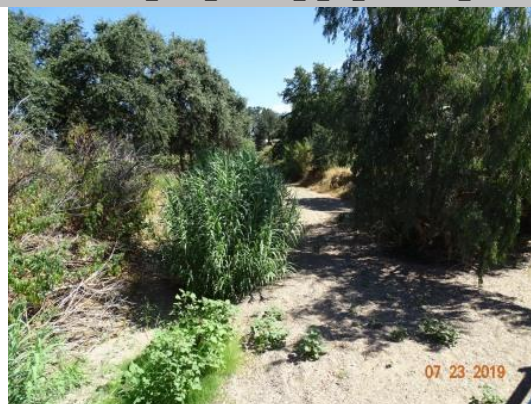
Photo 1 of 1 : CH_2019_NA0019_3_46_20190726_00015.jpg

Rating **	M	Issue No.	46	GPS Lat/Long
Issue Type +	Ma	Location *		40.017400 °
Category	Rivers, Channels & Designated Flood			-122.146540 °
Item	Vegetation & Obstructions			
DWR ID	DWR_NA0019_3_c_2012_46			
Action/Comments				
Inspector Comments: Remove vegetation obstructing the channel before winter. Arrundo should be eradicated.

Downstream view of McClure Creek from Hamilton Road.

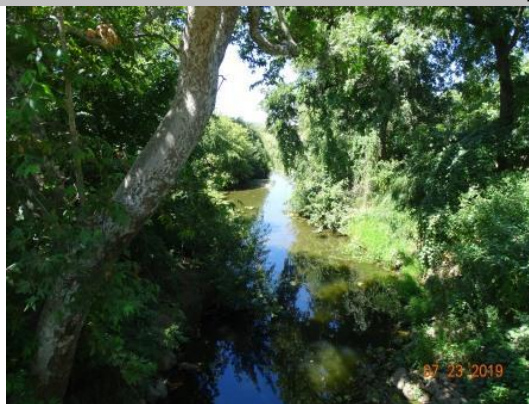
Photo 1 of 1 : CH_2019_NA0019_4_1_20190726_00007.jpg

Rating **	A	Issue No.	1	GPS Lat/Long
Issue Type +	Ma	Location *		40.157120 °
Category	Rivers, Channels & Designated Flood			-122.164250 °
Item	Vegetation & Obstructions			
DWR ID	DWR_NA0019_4_c_2012_1			
Action/Comments

Upstream view of Salt Creek from the bridge.

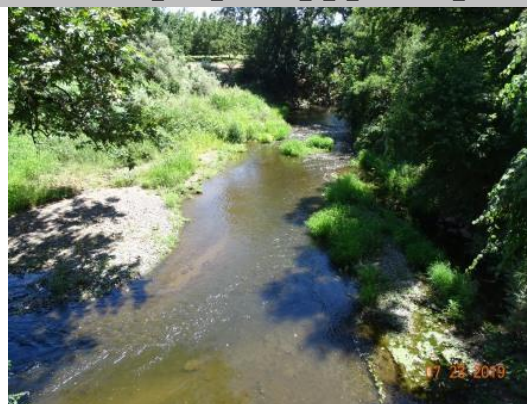
Photo 1 of 1 : CH_2019_NA0019_4_6_20190726_00008.jpg

Downstream view of Salt Creek from the bridge.

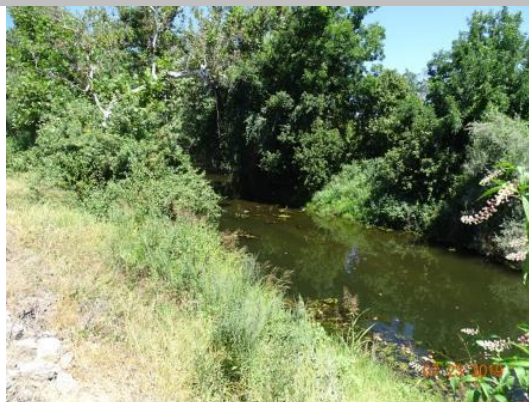
Photo 1 of 1 : CH_2019_NA0019_4_21_20190726_00009.jpg

Check Point / View				
2,800' upstream of downstream limit / Up				
Rating **	A	Issue No.	21	GPS Lat/Long
Issue Type +	Ma	Location *		40.151480 °
Category	Rivers, Channels & Designated Flood			-122.157590 °
Item	Vegetation & Obstructions			
DWR ID	DWR_NA0019_4_c_2012_21			
Action/Comments

Upstream view of the Salt Creek, 2800 feet upstream of the confluence with Sacramento River.

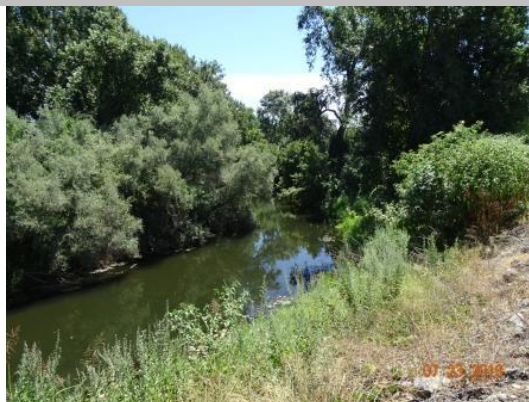
Photo 1 of 1 : CH_2019_NA0019_4_26_20190726_00010.jpg

Rating **	A	Issue No.	26	GPS Lat/Long
Issue Type +	Ma	Location *		40.151480 °
Category	Rivers, Channels & Designated Flood			-122.157590 °
Item	Vegetation & Obstructions			
DWR ID	DWR_NA0019_4_c_2012_26			
Action/Comments

Downstream view of the Salt Creek, 2800 feet upstream of confluence with Sacramento River.

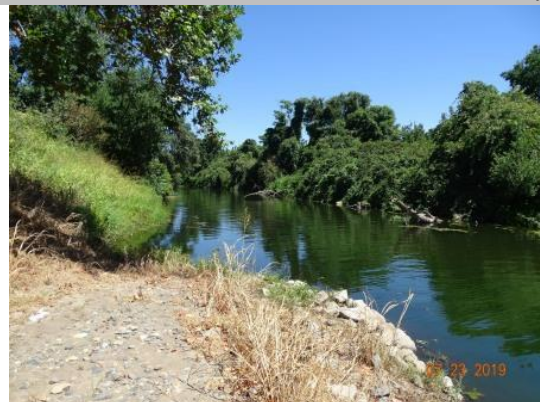
Photo 1 of 1 : CH_2019_NA0019_4_31_20190726_00011.jpg

Check Point / View				
100' upstream of confluence with Sac. R. / Up				
Rating **	A	Issue No.	31	GPS Lat/Long
Issue Type +	Ma	Location *		40.147230 °
Category	Rivers, Channels & Designated Flood			-122.154420 °
Item	Vegetation & Obstructions			
DWR ID	DWR_NA0019_4_c_2012_31			
Action/Comments

Upstream view of Salt Creek from the confluence of the Sacramento River.

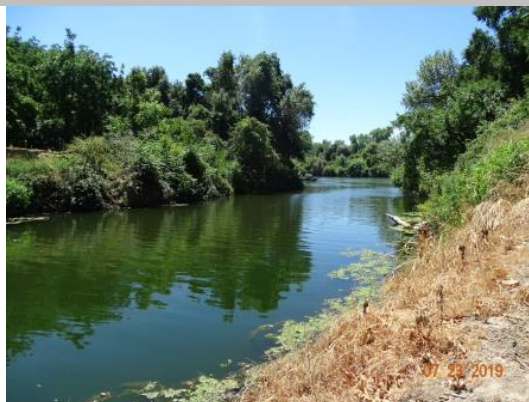
Photo 1 of 1 : CH_2019_NA0019_4_36_20190726_00012.jpg

Check Point / View				
100' upstream of confluence with Sac. R. / Down				
Rating **	A	Issue No.	36	GPS Lat/Long
Issue Type +	Ma	Location *		40.147230°
Category	Rivers, Channels & Designated Flood			-122.154420°
Item	Vegetation & Obstructions			
DWR ID	DWR_NA0019_4_c_2012_36			
Action/Comments

Downstream view of Salt Creek and the confluence with the Sacramento River.
